**TEARDOWN AND INSPECTION OF THE CUMMINS  
VTA-903 - EVALUATED USING THE SINGLE COMMON  
POWERTRAIN LUBRICANT (SCPL)**

**INTERIM REPORT  
TFLRF No. 450**

by  
**Adam C. Brandt  
Edwin A. Frame**

**December 2013**

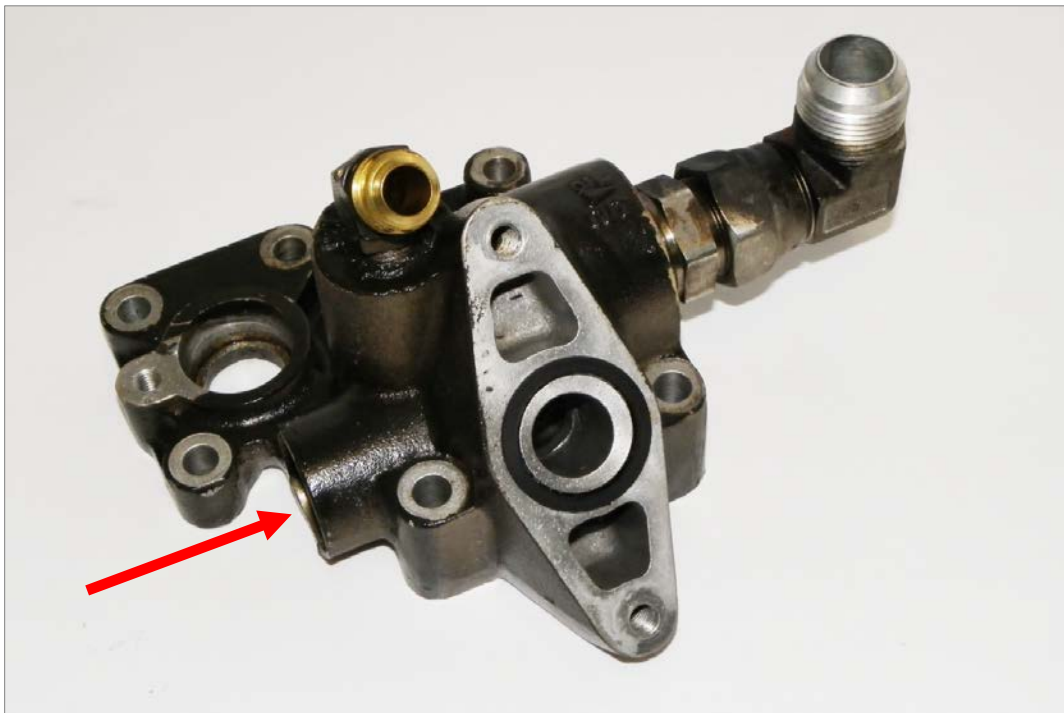
**Figure 81. Oil Cooler Mounting Assembly/Secondary Relief/Bypass Valve Location**

For reference, Figure 81 below shows the oil cooler mounting assembly where the secondary relief piston/bypass is located. The location of the photo shown in Figure 80 above was taken through the opening shown directly facing in the photo below. The secondary relief piston/bypass valve is inserted through the bore at the bottom of this housing (note: 90° steel AN fitting considered the top of the housing for frame of reference, secondary relief piston bore opening and movement axis denoted by red arrow).

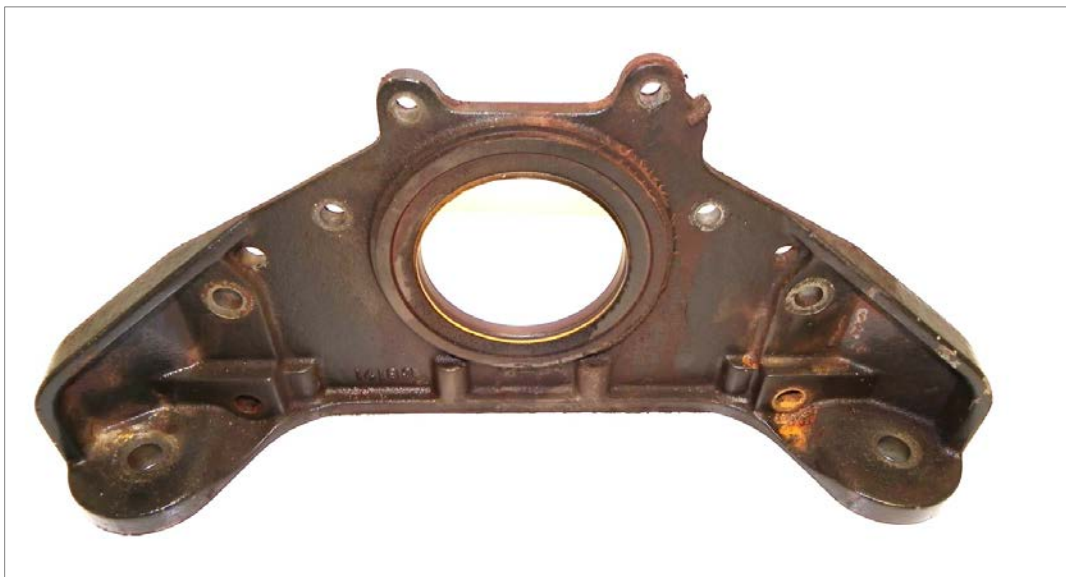
**Figure 82. Crankshaft Seal Housing at Balancer**

In addition to the oil pressure and flow fluctuations, a significant oil leak was noted by TARDEC at the engines “rear main” seal during dyno testing. TFLRF was asked to pay particular attention to this area upon disassembly to try and indentify the cause of the leak. Upon inspection, it was found that the front crankshaft seal (harmonic balancer end) was the area of the leak as opposed to the rear seal (flywheel end). This was determined by significant accumulation of oil and dirt in this area of the engine. The rear main seal (flywheel end) was clean and showed no evidence of leaking. This discrepancy in terminology is likely just a result of frame of reference differences when discussing the engine, and is compounded by the fact that the Cummins 903 engine sits “backwards” from normally expected when installed into the Bradley Fighting Vehicle (i.e. flywheel end facing front of vehicle). The front crankshaft seal carrier assembly can be seen below in Figure 82.

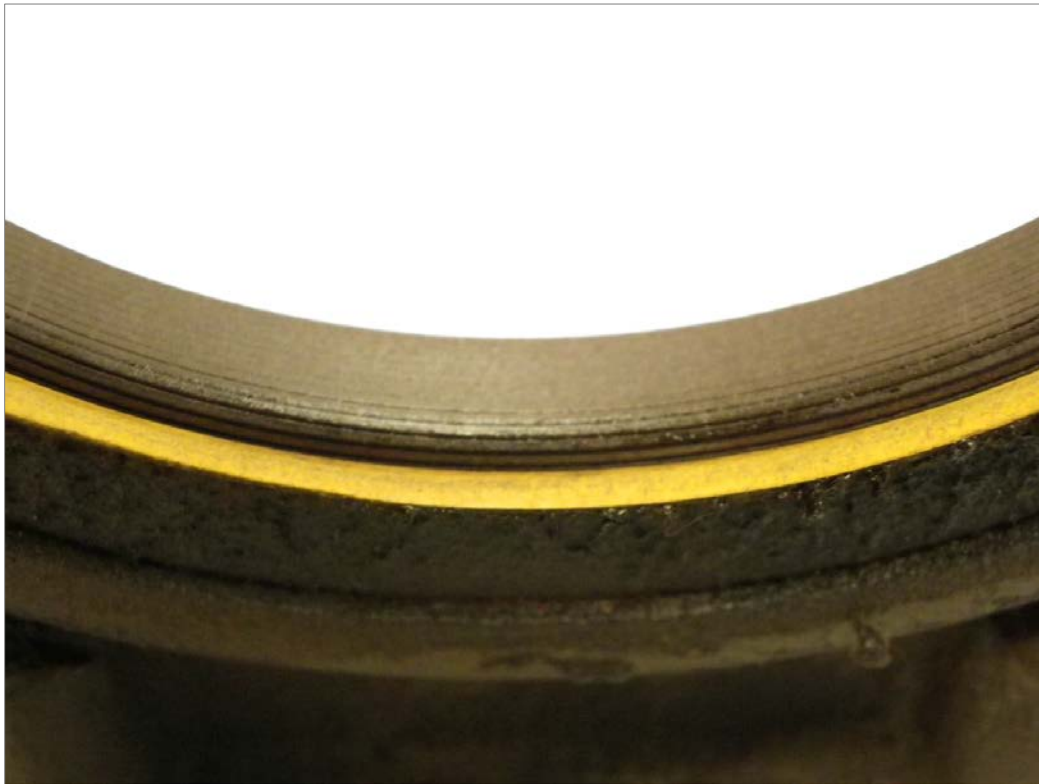
**Figure 83. Front Crankshaft Seal Surface Close-up (Balancer End)**

Close inspection of the seal didn't reveal any obvious defects that would result in oil leaks at this sealing surface. The sealing lip showed uniform wear, with no heavy abrasion or tears present in its surface. The seals lip was also found to be pliable, and would be expected to work as it should. The seal itself also appeared to be installed square and flush in the carrier. Figure 83 shows a close up of the seal lip. Uniform condition was noted around the entire seal circumference.

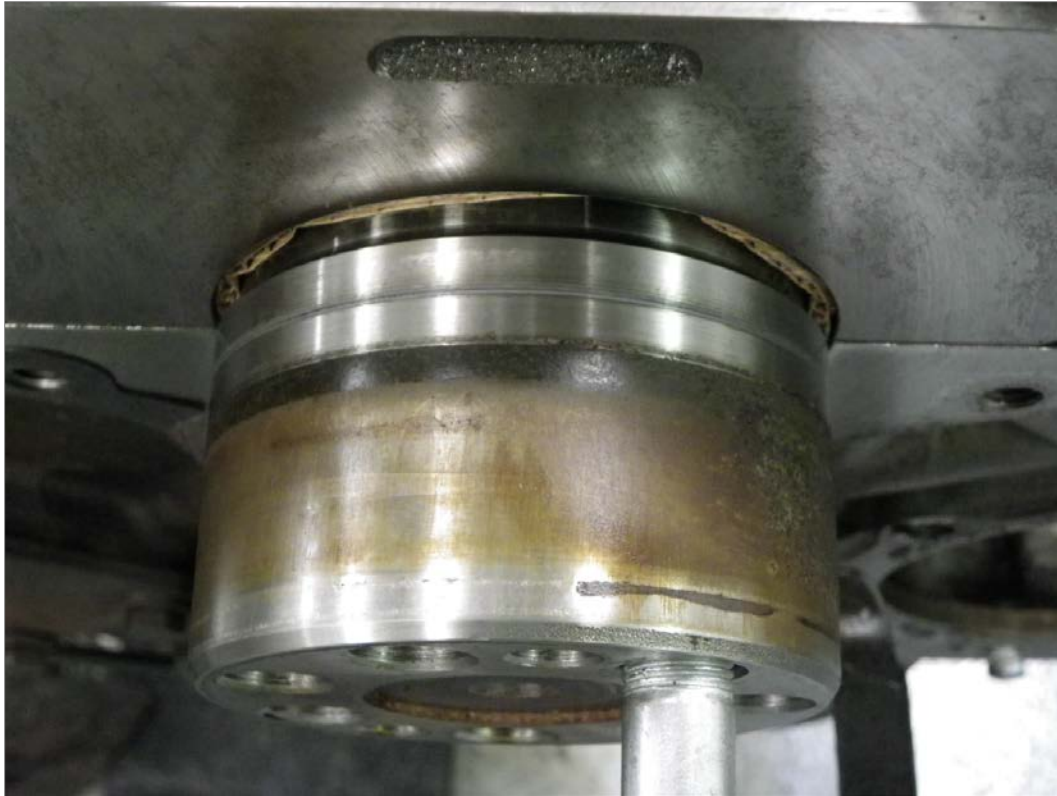
**Figure 84. Crankshaft Front Sealing Surface (Balancer End)**

In addition, the crankshaft sealing surface was inspected for heavy wear or defects that would contribute to leaks in this area. Although a visible wear pattern was noted where the seals lip rides on the crankshaft surface (noted by the dark line appearing in the surface), there was not significant physical wear to suggest problems. Just past the sealing surface was a heavy accumulation of rust on the surface of the crankshaft, but this area appears to be well outside the area of concern for the seal. This area of the crankshaft is shown in Figure 84.

At this time, a definitive cause for the leak in this area was not apparent, although evidence of the leak is obvious upon disassembly. The front seal carrier is bolted to the front of the engine with multiple bolts, but is ultimately located in the x and y direction by the use of one circular dowel pin, and a second semi-circular pin on either side of the seal carrier. It is possible that alignment of the carrier in respect to the engine block (i.e. crankshaft centerline) could be offset and contribute to leaks. Although it would be expected to show wear/evidence on the seal lip surface if the seal was not concentric to the crankshaft due to offset loading. This was not the case. Another potential contributing factor could be not related to the mechanical condition of the seal and sealing surface. Excessive crankcase pressure can also contribute to leaks at sealing interfaces, but data was not apparent for crankcase pressure in the TARDEC draft report, only blow by flow rate. Although there is not enough evidence to determine the true cause of the oil leak, nothing was found that suggested the candidate SCPL as a contributing factor. During its development, the SCPL underwent extensive industry standardized seal compatibility testing,
